A Grounds for the Greater Good: Evoking the Spirit of the Meeting House

All Souls Unitarian Universalist Church West Brattleboro, VT

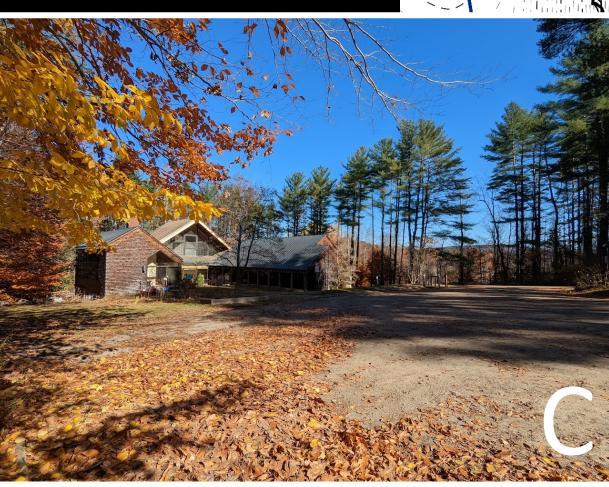
Snow piles off roof and falls into main walkway

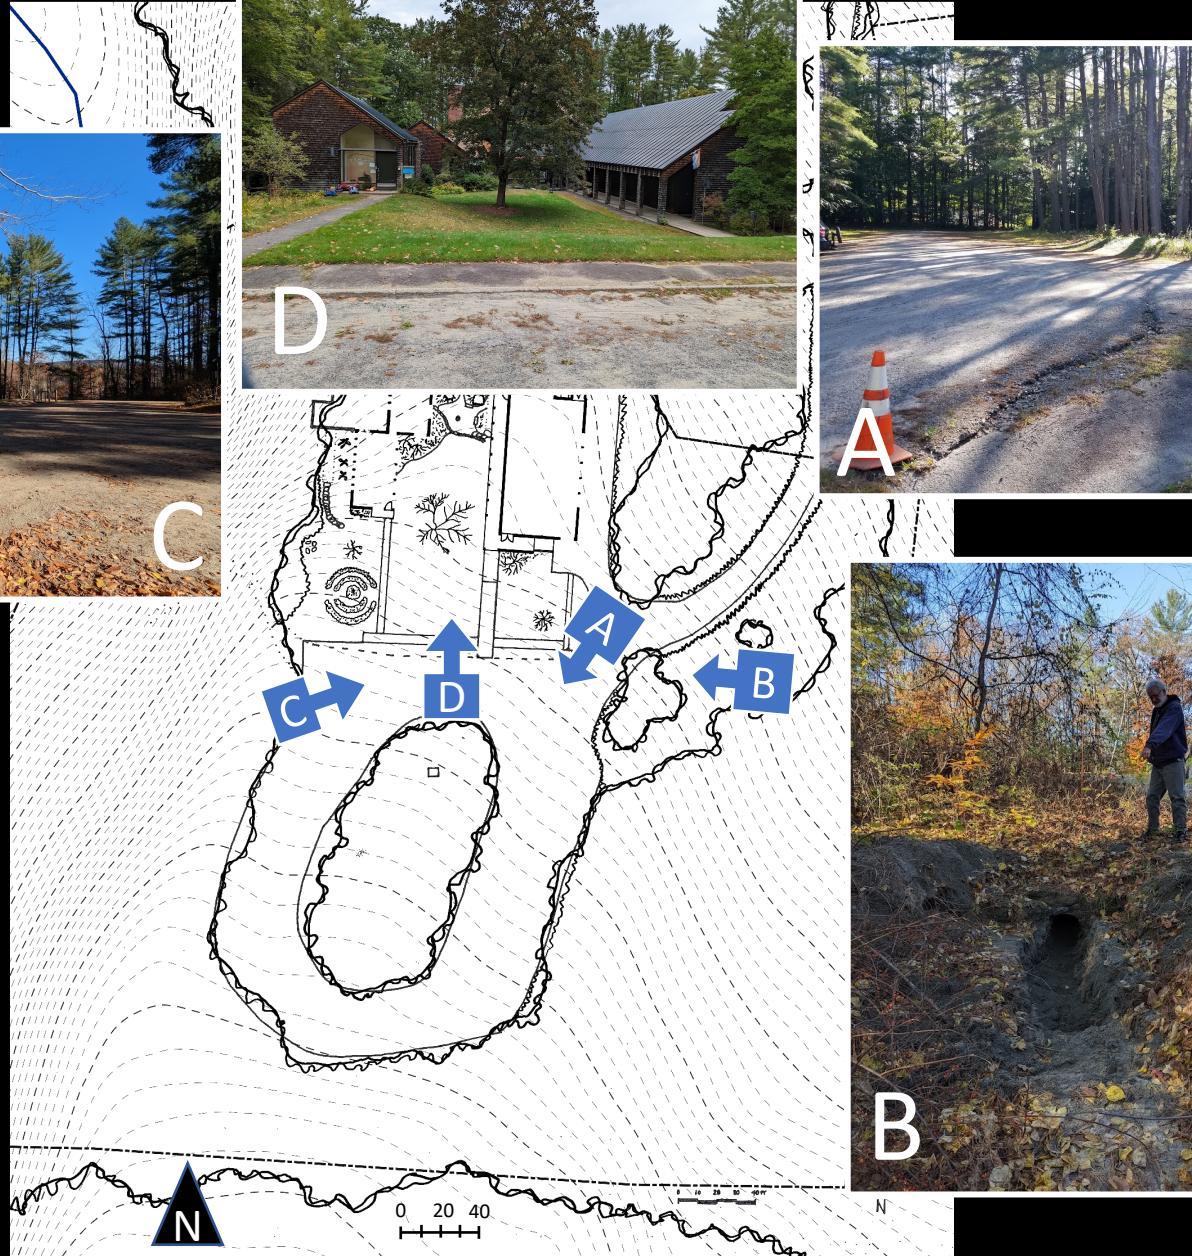
Main Lot

Lower lot becomes dangerously icy in the winter

Deep rills in lot a driving/ walking hazard

Sediment buildup in the swale below main walkway and clogs culvert

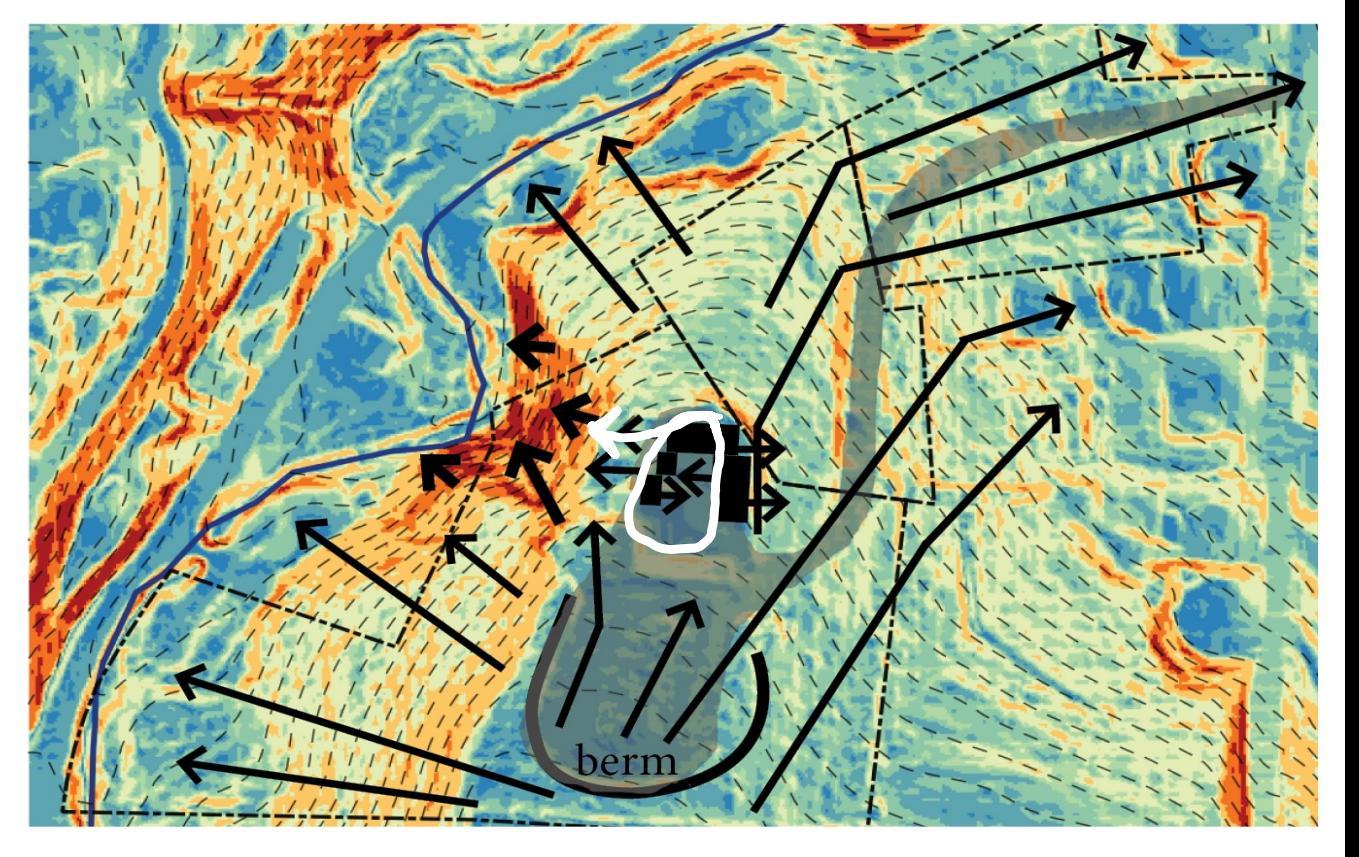
Drainage

<= 2.0000
2.0000 - 5.0000
5.0000 - 8.0000
8.0000 - 10.0000
10.0000 - 15.0000
15.0000 - 25.0000
25.0000 - 33.0000
> 33.0000

- \longleftarrow direction of flow
- ← most intense flow

Property minimally affected by upslope water

Important to consider downslope neighbors

Steepest slopes seem linked to edges of current impermeable space

Active erosion on northwest corner where stormwater is directed from building and lot

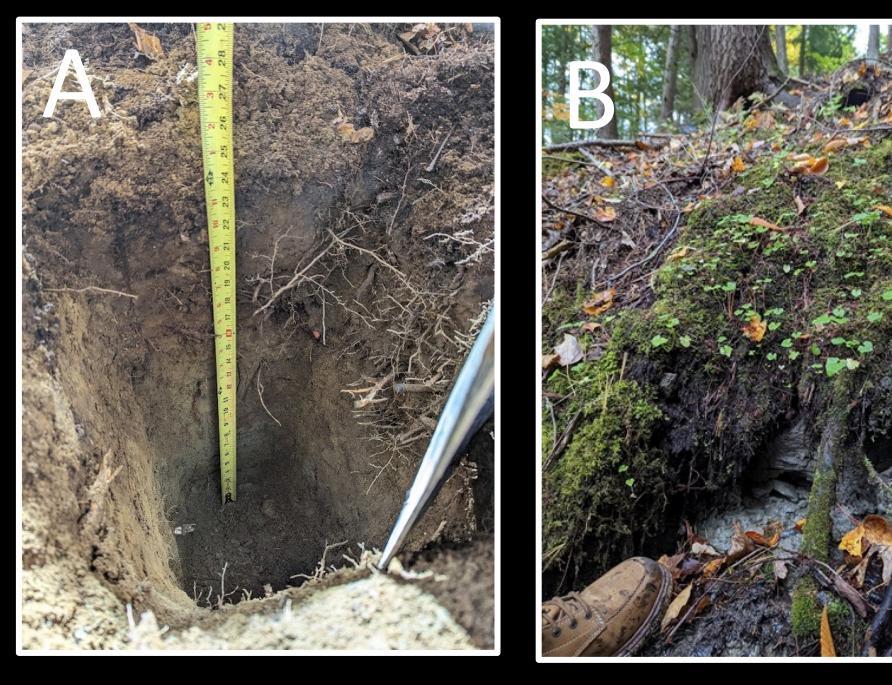
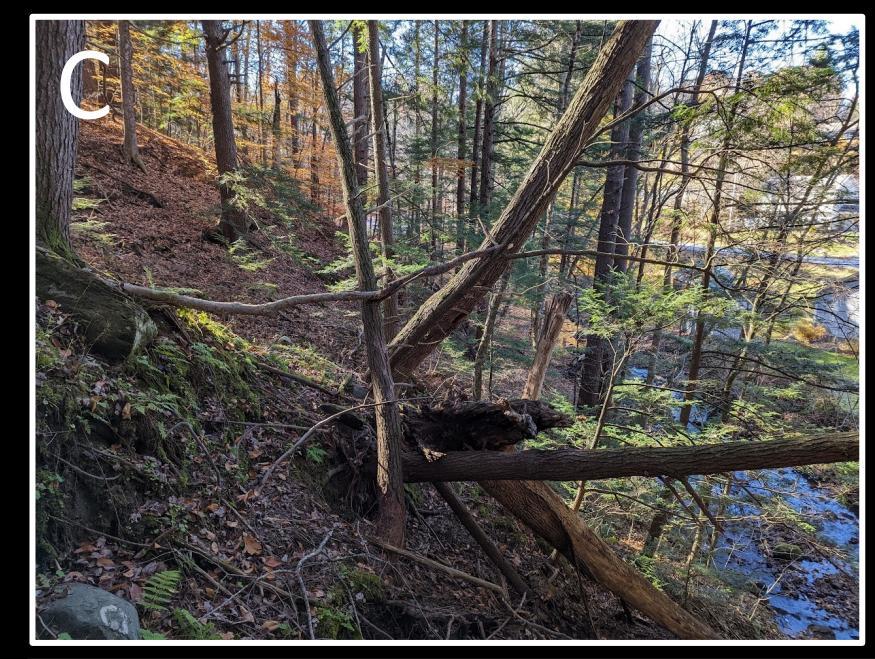
Soils and Erosive Slope

Brook at the base of western slope considered a **Highest Priority Surface Water and Riparian Area**. Is part of the Whetstone Brook Watershed that leads to the Connecticut River

Well-draining, fine sandy loam expanses most of the property... but there is a hard pan layer ~2 feet deep on the steep western slope

Unclear the **extent of hardpan on east side** of property and proximity to bedrock

Redirecting water off the west side further upslope may result in **same erosion problem over time**

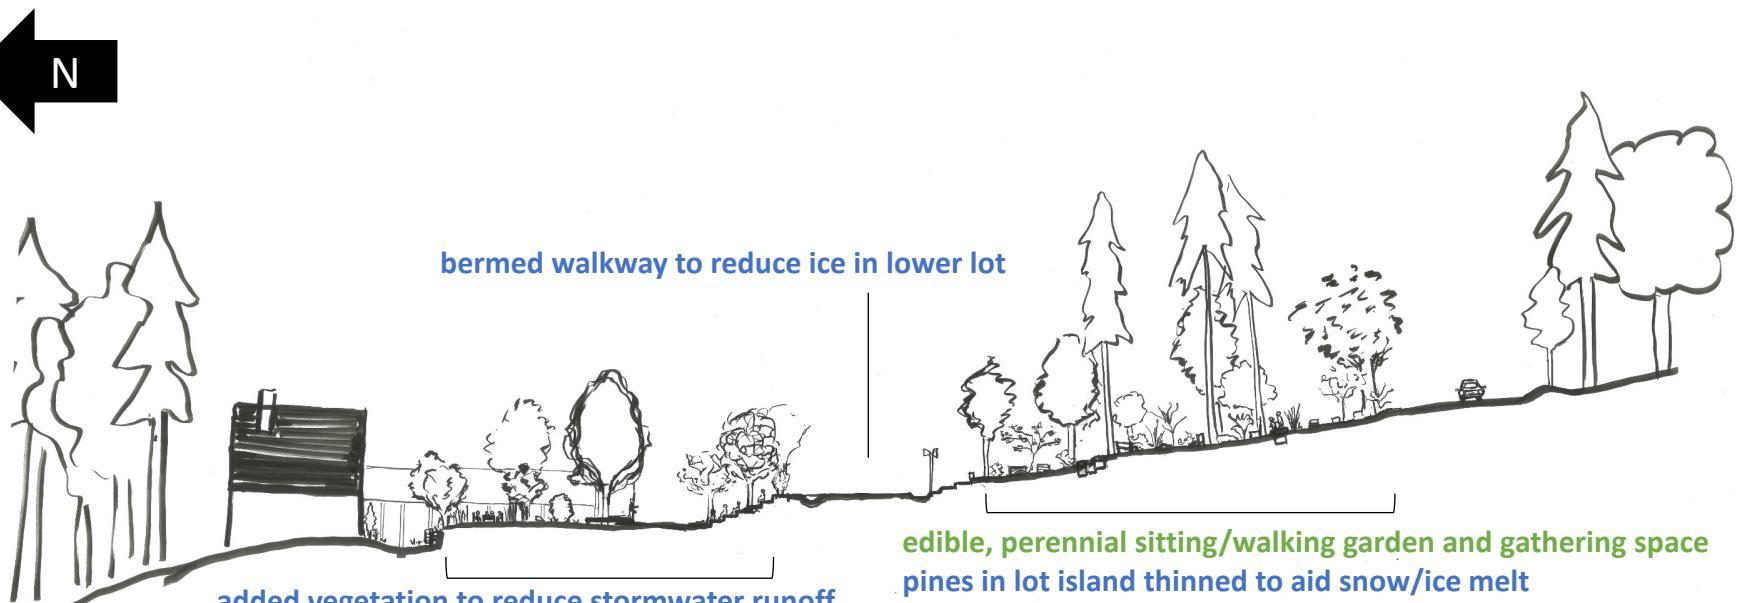
Design #1: Easy Adaptation

ADA parking | 3-5 spots Trash and compost | Secure area under fire escape stairs

Main lawn stormwater | Install spreader, added vegetation in central lawn area Lot runoff | Redirect to central island and eastern forest Ice/snow mitigation | Paved, crowned walkway berm, tall pines thinned to provide more opportunity for snow melt

Pine island | Walking/sitting edible, perennial garden and small gathering space

Main lawn | Developing amphitheater space to seat 50 Norway Maple | Shaded platform underneath Forest Management | Remove diseased hemlocks along power line

added vegetation to reduce stormwater runoff amphitheater and platform under Norway maple

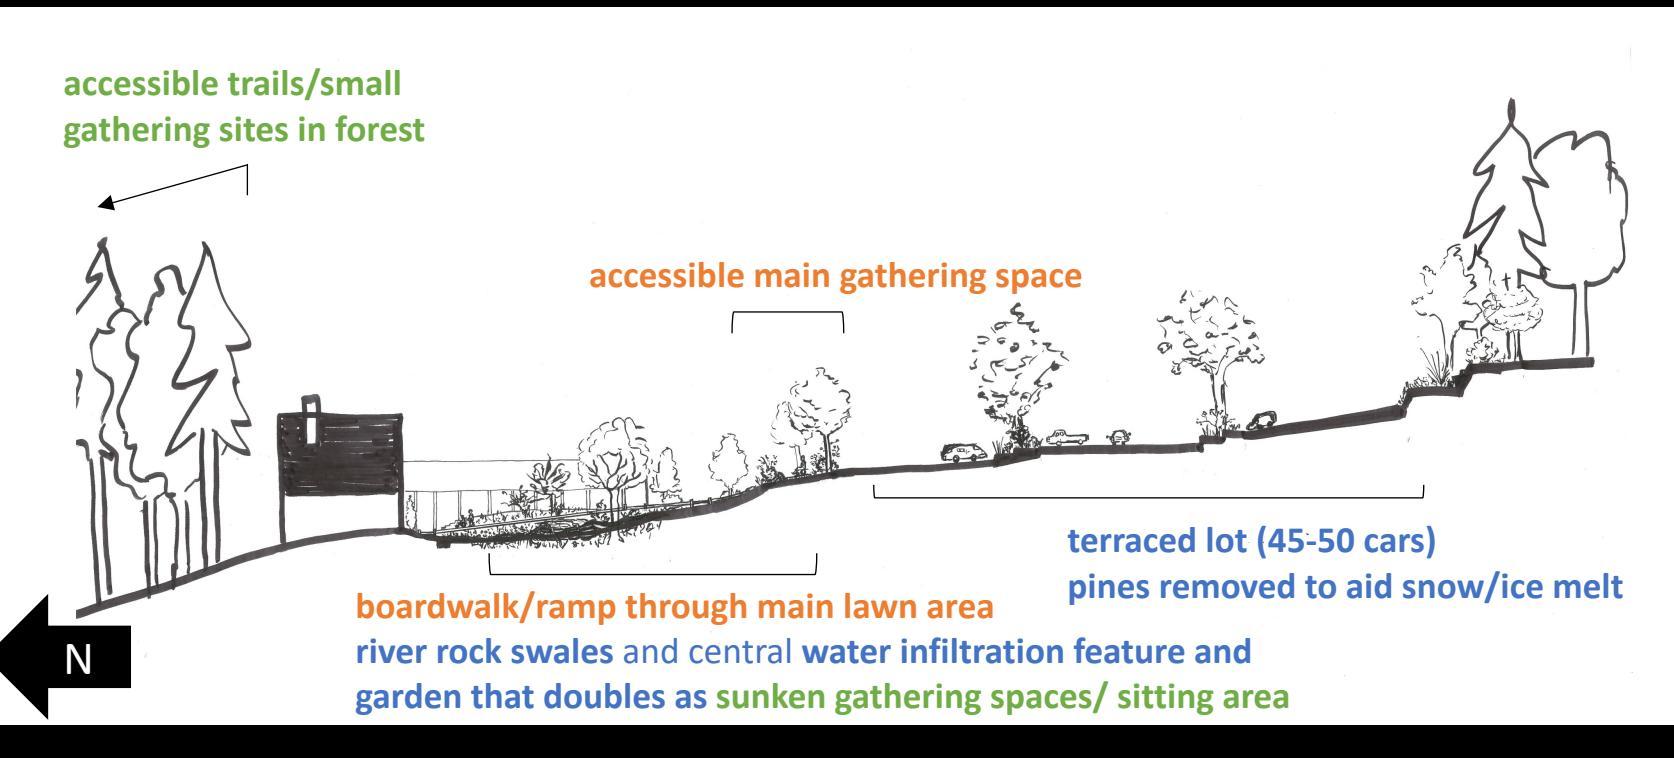
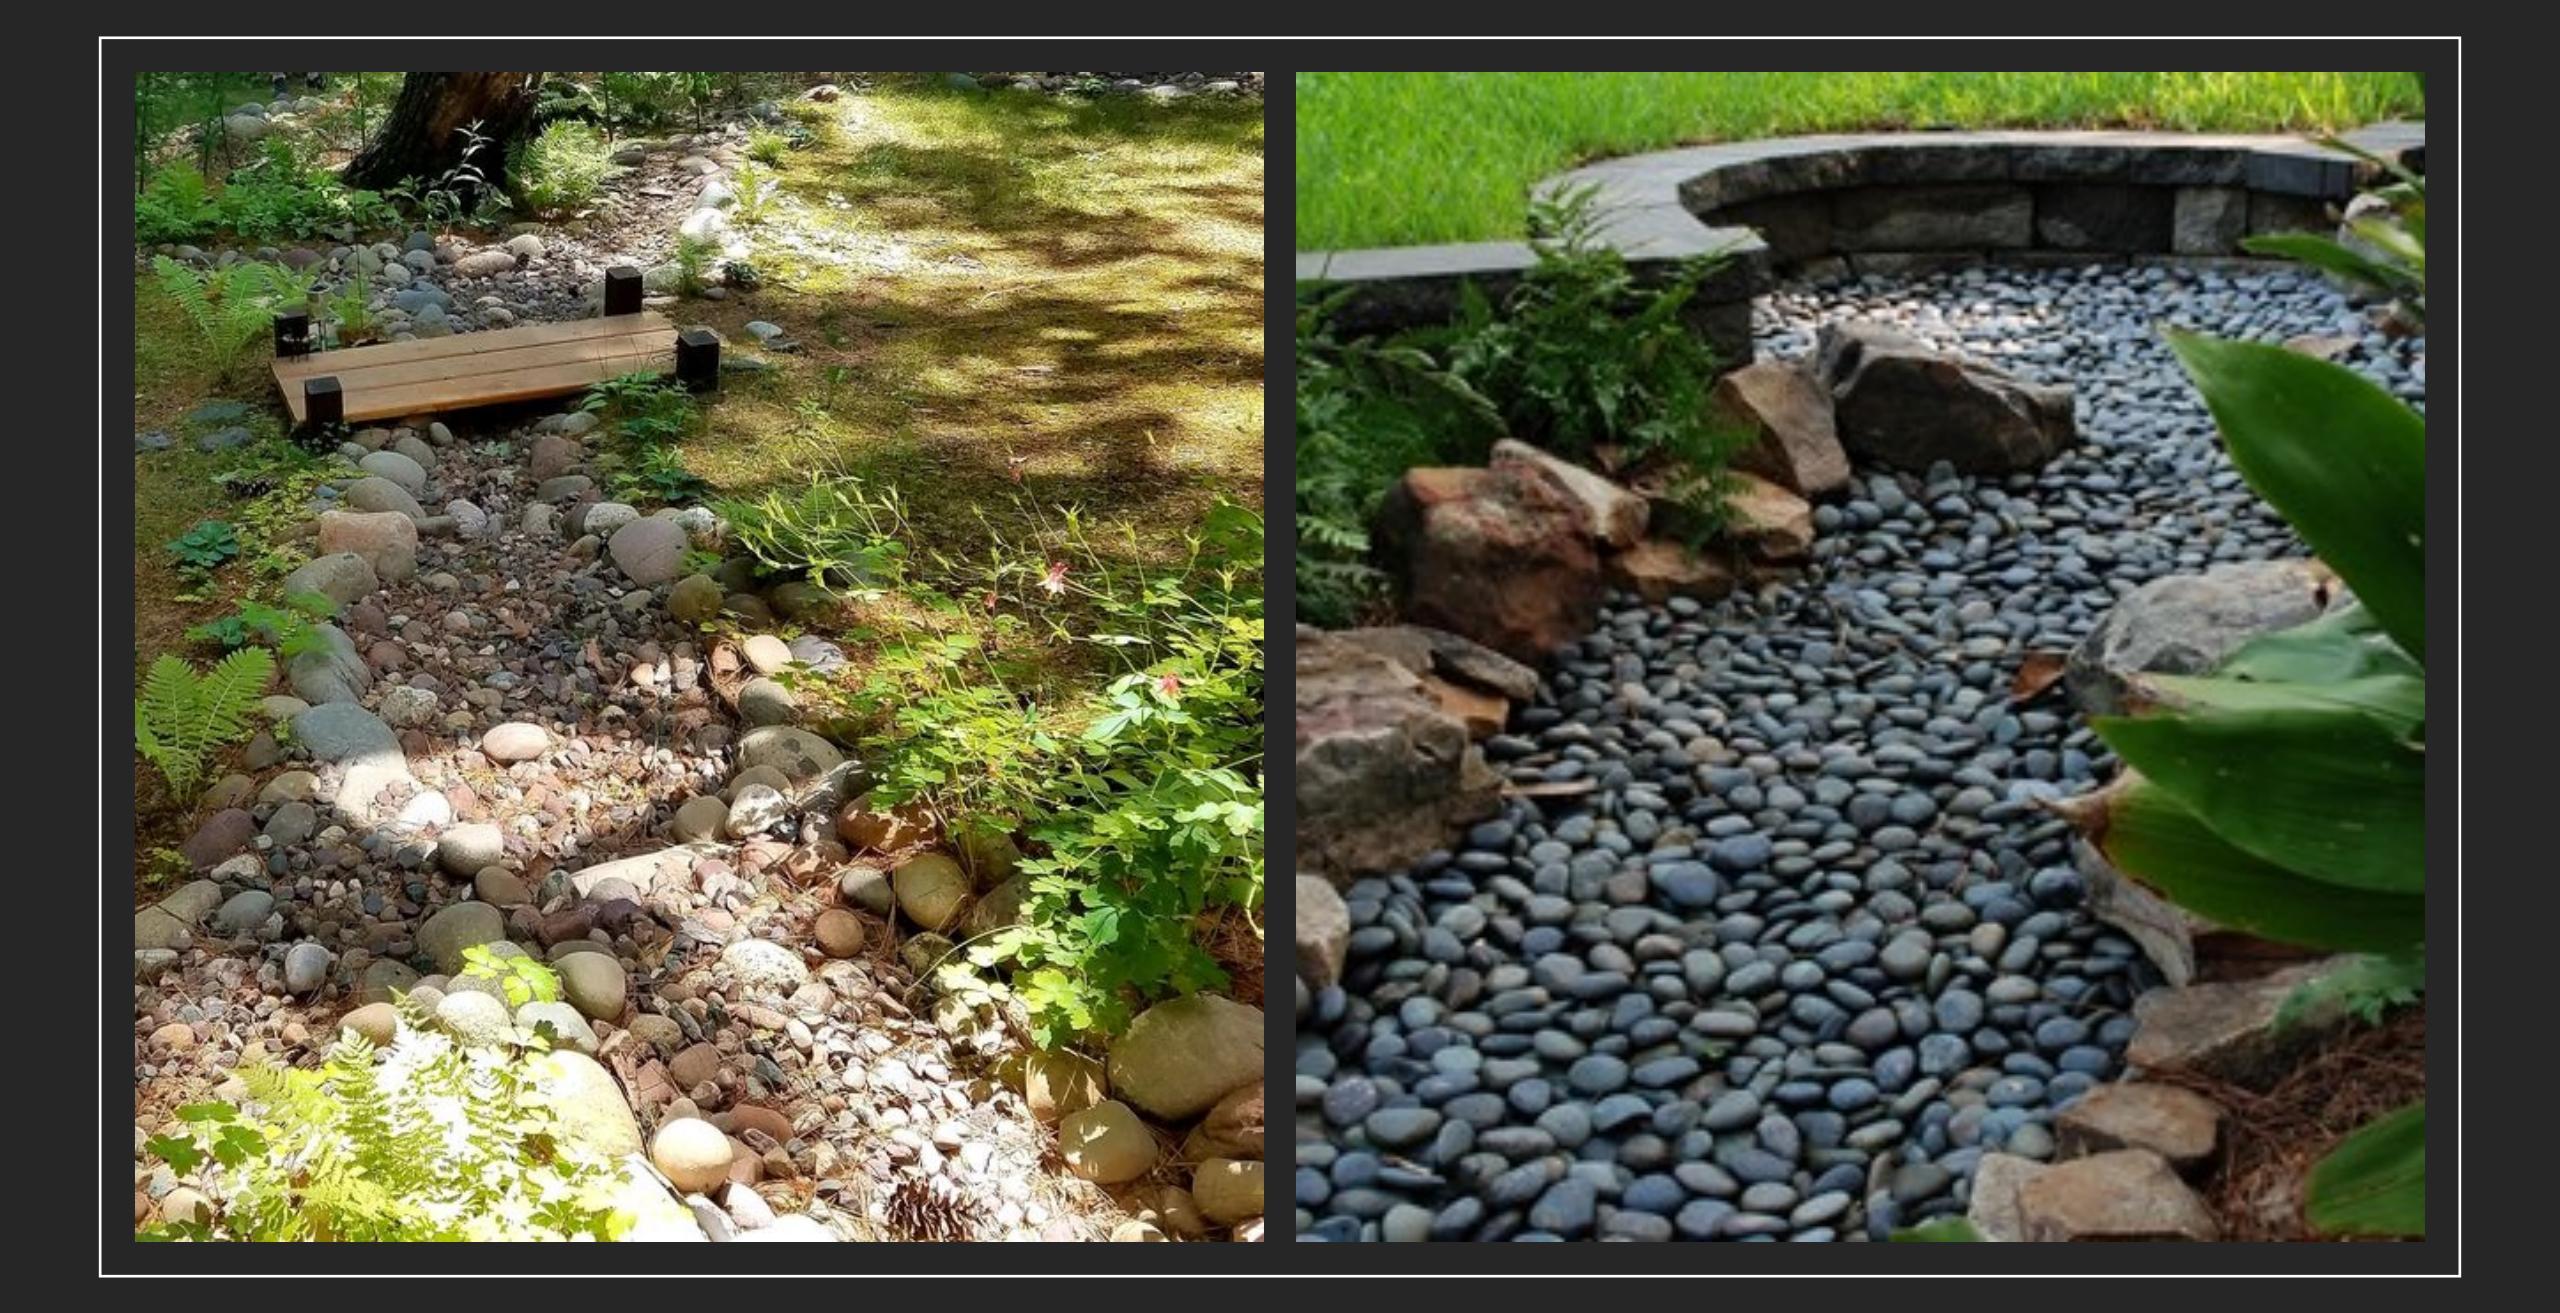
Design #2: Access Forward

ADA parking | 5-6 spots

Trash and compost | Bump out north of the fire lane

ADA main entrance | Boardwalk/ramp through main lawn area Main lawn stormwater | Redirect pipe to northern slope, install river rock swales and central water infiltration feature and vegetation to redirect water away from building and ramp and reduce run off

Lot runoff | Downsize parking lot to 50 to shrink impermeable space, most water redirected to planted infiltration basins to the east

Ice/snow mitigation | Most tall pines removed, regrade main Iawn area for water/snow to move away from building Forest | Acccessible trails and gathering spaces to the north and east

Main lawn | Accessible main gathering space at the top of the main lawn, stormwater management area doubles as an accessible small gathering space/sitting area

Forest Management | Remove diseased hemlocks along power line

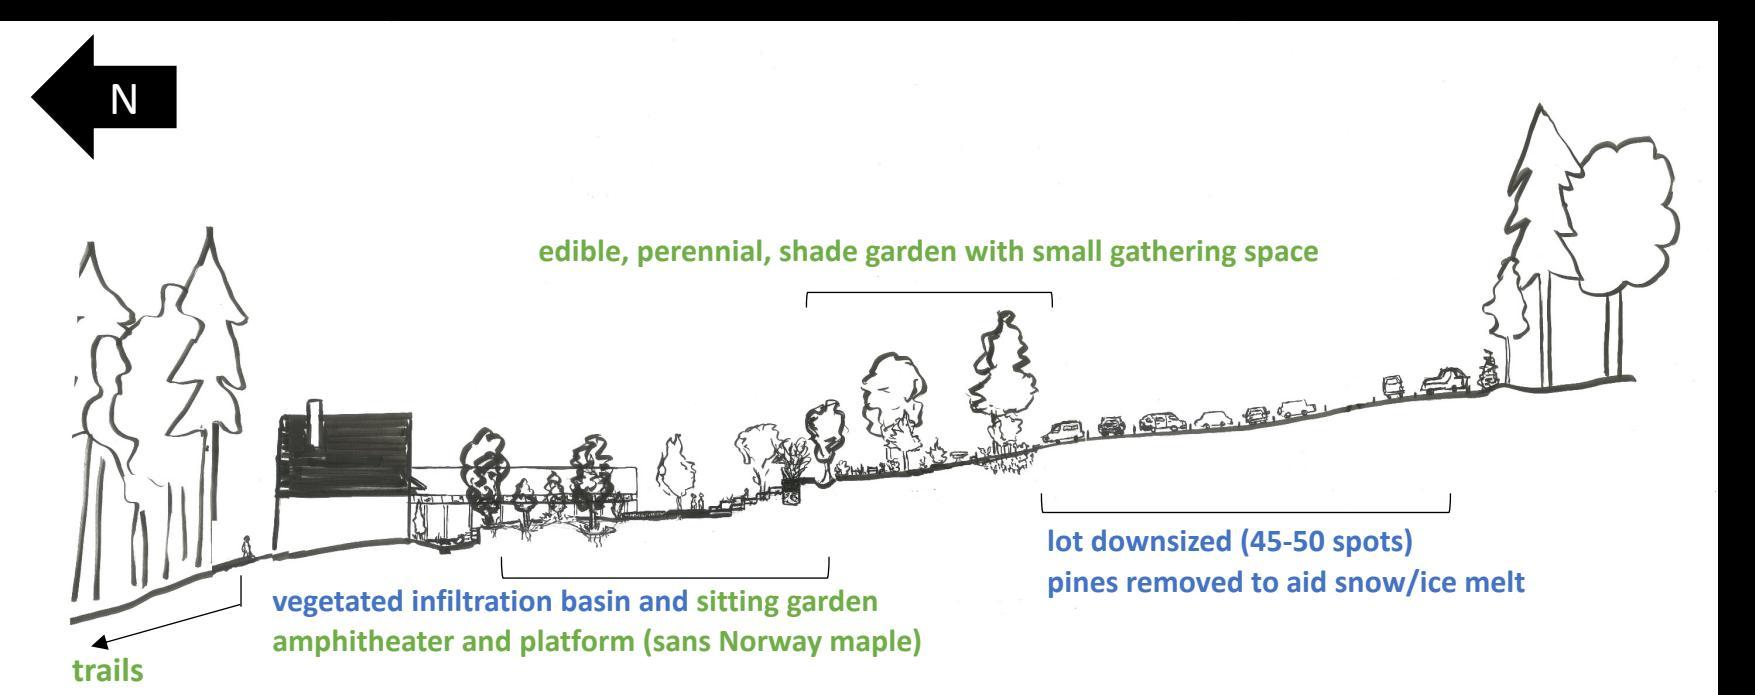
Design #3: Eco Retreat

ADA parking | 2-4 spots

Trash and compostBump out east of fire laneMain lawnVegetated infiltration basin gardenIce/snow mitigationSolar overhang to extendsnowfall away from main walk, all pinesremoved

Lot runoff | Downsize parking lot to 45-50 spots shrink impermeable space, east rain garden catchment

Slope Stabilization | Bioengineered NW slope stabilization and streambank restoration

Forest | Extensive trails and forest gathering spaces to the north and east, observation deck style platform off steep west slope and multipurpose gazebo in east forest for solitude/small gatherings

Main Lawn | Midstory trees planted to shield building from sun to the south and east, edible, perennial, shade-providing garden sitting area above main lawn, developing amphitheater space to seat 50

Norway Maple | Remove to create a platform feature area Forest Management | Remove diseased hemlocks along power line, selectively thin SW forest in phases of hemlock, beech to proactively promote succession
